EU Refinery

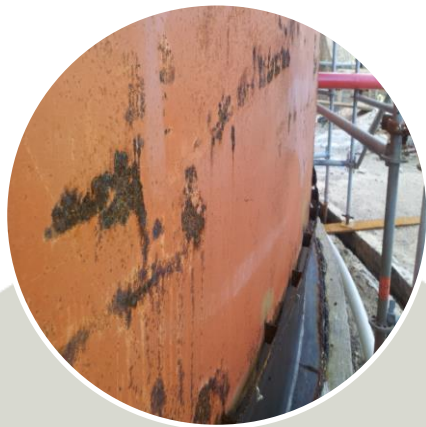
- Oil storage tank was badly corroded and required coating with UV stable coating
- Surface preparation was restricted due to the tanks location
