Solvent wash down area- UK

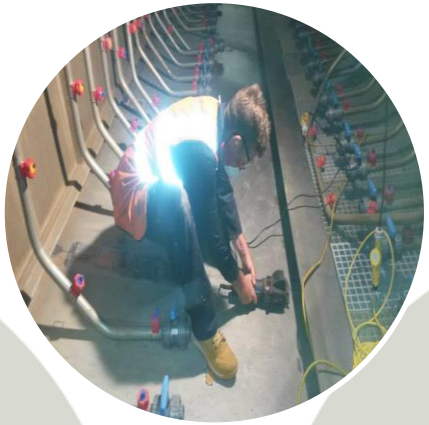
- Global car parts manufacturer awarded a further contract to Mark Specialist Coatings to seal the leaking joints on a wash down tunnel
- The tunnel was constructed and the solvent wash was leaking into other areas of the factory

- All surfaces were mechanically abraded using MBX Bristle Blasters

- To seal the joints 301 Epoxy Resin and Hardener was coated on to the joint
- While still wet glass tape was incorporated into resin
- Once cured 1 x coat of Resichem 507 DWPU was applied at 1mm wet film thickness
